TEMPORARY IMMERSION AND DUST TEST REPORT

Company : GlacialTech Inc.
 Address : 9Fl., No. 352, Sec. 2, Jung Shan Rd., Jung He City, Taipei 235,
 Taiwan, R.O.C
 Product Name : LED Driver
 Model Name : GP-LS35P-xyzzz; xx can be 30 or 42 or 48; y can be A or B or blank;
 zzz can be any alphanumeric or blank.
 Date Received : JUL 24, 2009
 Date Tested : JUL 24, 2009 ~ JUL 27, 2009

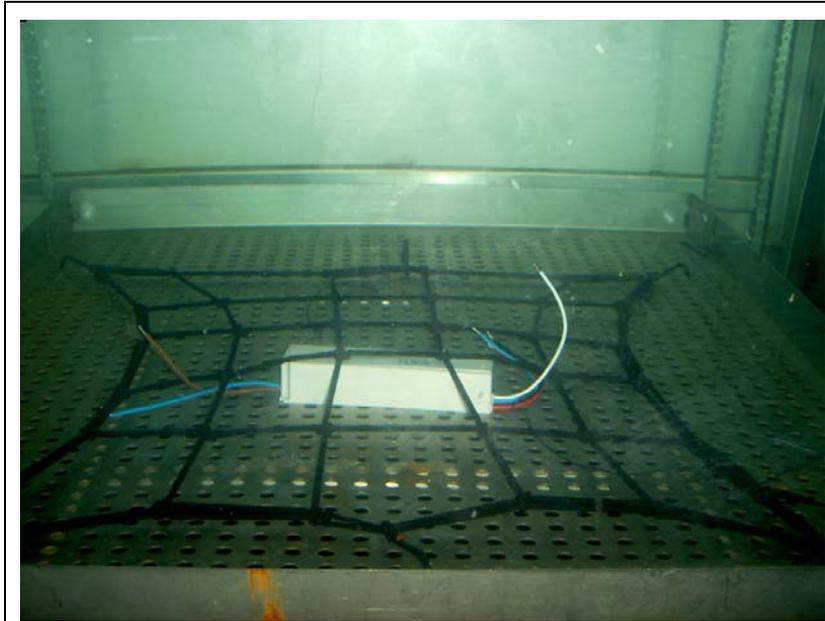
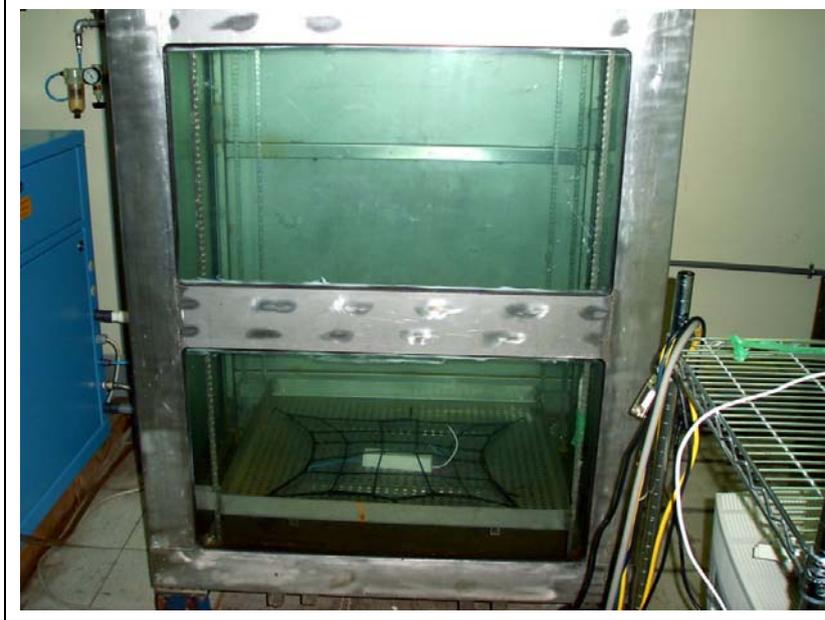
Attachment 1 : Photo of temporary immersion test setup

The lowest point of unit is locating 1000mm below surface of the water.

The duration of test is 30 minutes

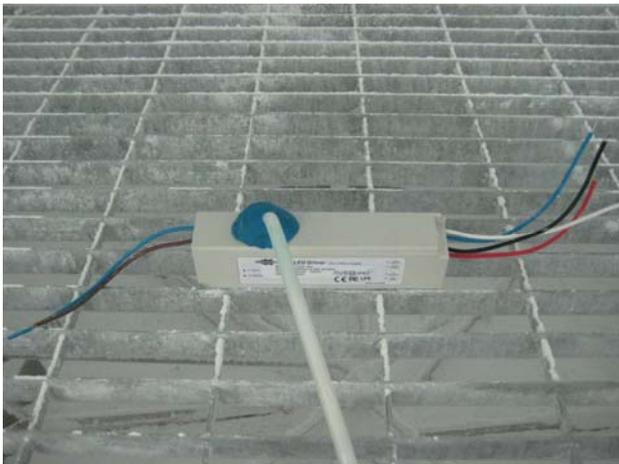
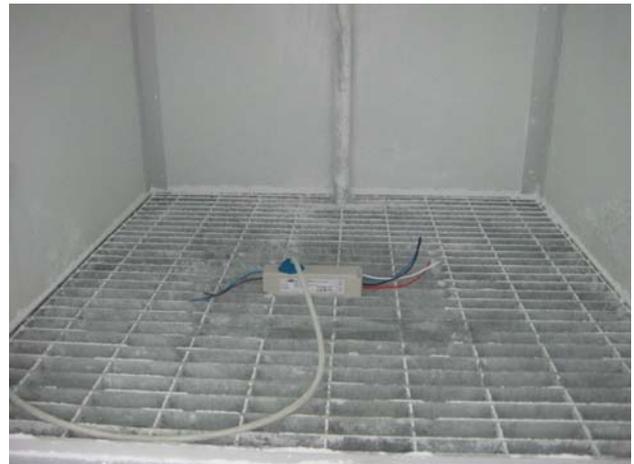
Attachment 2 : Photo of temporary immersion test setup

Before test

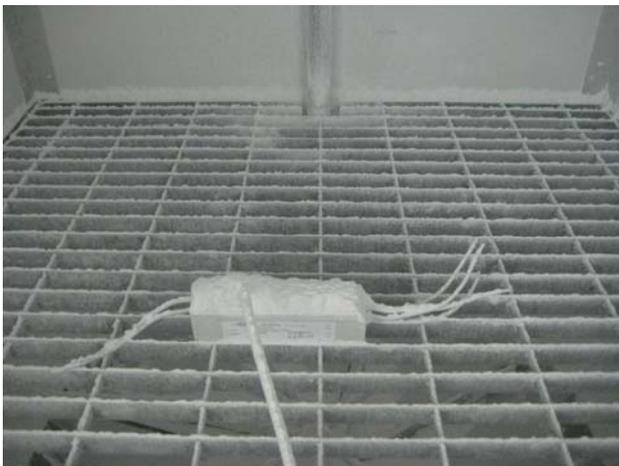
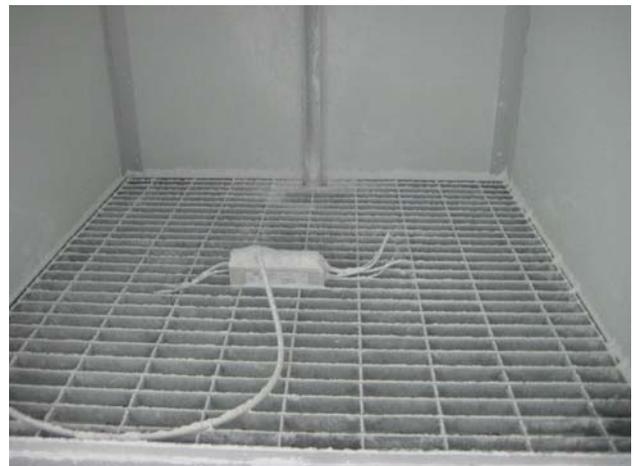
After testing, visual inspection showed no water permeated into unit (the inner unit was dry). No functions check requested from customer.

After test

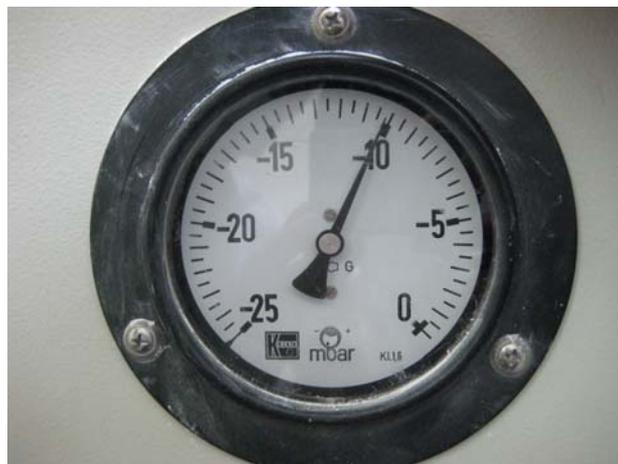
Depression level : 10 mbar

Depression level

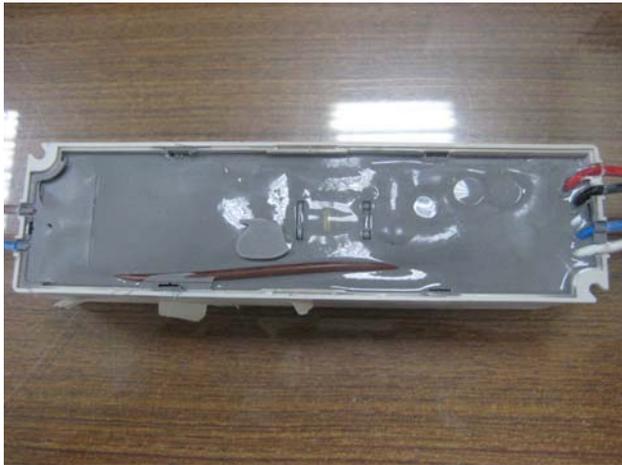
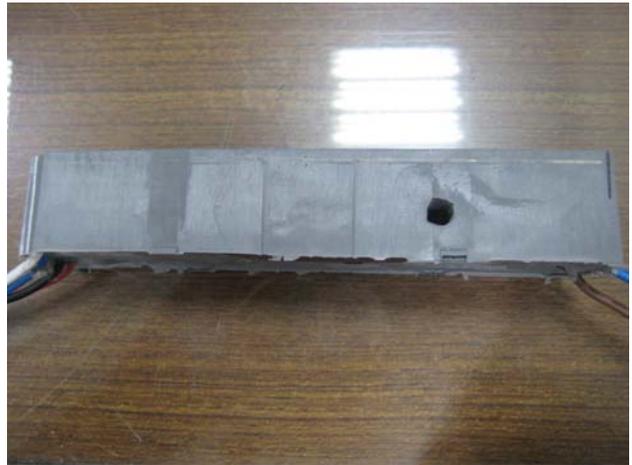
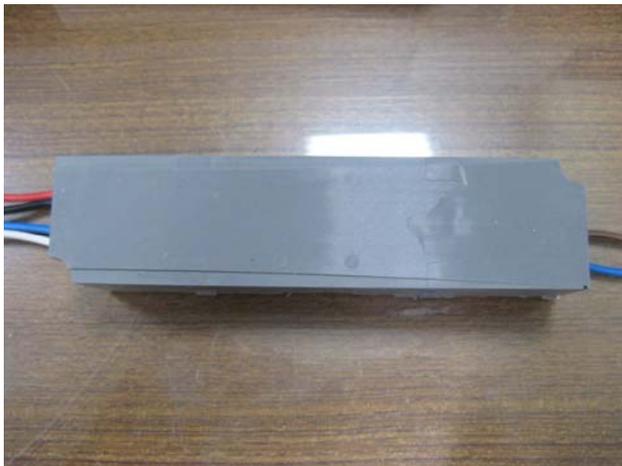
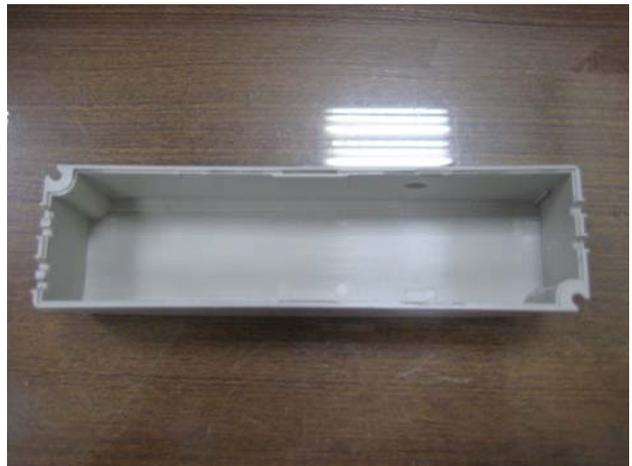
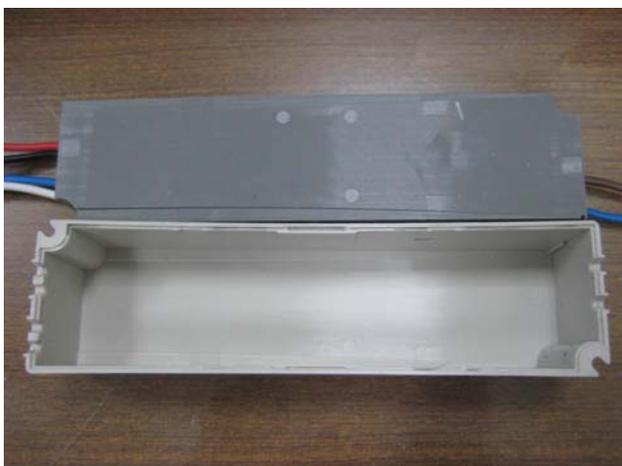
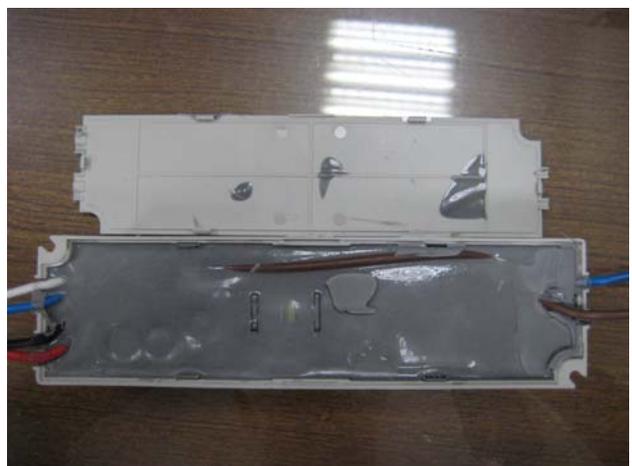
Attachment 3 : Photo of unit after dust test / temporary immersion test

After testing, visual inspection showed no dust particle permeated into unit. No functions check requested from customer.

No dust permeated/ No water permeated
